**Flood Control Project Maintenance
Levee Inspections**

Fall 2018 Levee Maintenance Deficiency Summary Report

Sacramento River Basin

**Flood Control Project Maintenance
Levee Inspections****LMA District Cover Sheet****Fall 2018 Levee Inspection Results****Sutter Maintenance Yard Maintenance Area 0001**

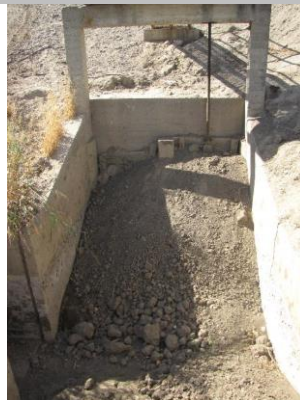
Photo 3 of 3 : UCIP_FA_2018_51875_70190.jpg

Item	DWR UCIP Field Study		39.290147 °	39.290147 °								
			-122.021525 °	-122.021525 °								
DWR ID	16427											
Comment Code												
Inspector Comment												
FS_ID:51875 DS_ID:16427 EP_NO: 9482 Repair Type: Non-Urgent Crossing Status: Found UCIP Comments: 5/3/2017 Abandoned- Needs to be done properly. (DWR Sutter Yard- A Freitag)10/24/2016 Abandoned.(DWR Sutter Yard- A Freitag)4/25/2016 Abandoned pipe. Needs to be properly plugged if it never gets used.4/20/2015 Same as last inspection. Structure is still buried.6/23/2014 Same as last inspection.12/17/2013 Same as last inspection.7/18/2013 Same as last inspection.10/19/2012 Structure is buried and non-operational. This crossing was listed in the USACE Periodic Inspection as ID# USACE_CESPK_MA1C_2010_p_0288 for sluice gate closed and backfilled on WS and full of sediment with wingwall cracked on LS. FIELD_STRUCT_DESC: *ABANDONED* 1 of 2: 36-inch reinforced concrete irrigation pipe through the levee at approximately 18 feet below the crown. Wooden slide gates on the waterside (WS) end. Sliding metal gate noted in O&M manual. Concrete headwalls located on both WS and landside (LS). O&M manual structure reference is 4'-9" x 9'-6" concrete box culvert. (Automatic Board Order (ABO) issued as Permit No. 9482, 1974 - Elizabeth M. Farnsworth) [Additional Reference(s): DWR Levee Log, 1992. USACE Sacramento O&M Manual 137, August 1955, (Station 370+90)]. FS Date: 5/23/2017 10:14:12 AM

View of crossing from WS side. WS blocked by sediment. 2 slide gates part of structure design.

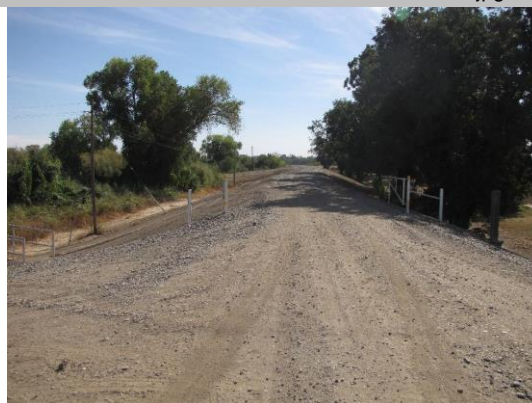
Photo 1 of 3 : UCIP_FA_2018_51876_70194.jpg

FS_ID:51876
DS_ID:17570
EP_NO: 9482
Repair Type: Non-Urgent
Crossing Status: Found
UCIP Comments: 5/3/2017 WS slide gate was unburied and crossing was being used for irrigaton during site visit.(DWR Sutter Yard- AFreitag)10/24/2016 WS slide gate was unbruied and opened.(DWR Sutter Yard- AFreitag)4/25/2016 WS slide gate was unburied and opened allowing water to flow through to LS fields.4/20/2015 Structure is operational. WS slide gate was unburied allowing water to irrigate the fields. It gets reburied during highwater season.

6/23/2014 Same as last inspection. Soli dug out again and water flowing through crossing.12/17/2013 WS screw gate was closed and buried by soil again.7/18/2013 WS screw gate has been cleared of dirt and is open to irrigate LS fields. LS outlet is still mostly blocked by sediment.10/19/2012 Structure is buried and non-operational. This crossing was listed in the USACE Periodic Inspection as ID# USACE_CESPK_MA1C_2010_p_0288 for sluice gate closed and backfilled on WS and full of sediment with wingwall cracked on LS. FIELD_STRUCT_DESC: 2 of 2: 36-inch reinforced concrete irrigation pipe through the levee, approximately 18 feet below the crown. Wooden slide gates on the waterside (WS) end. Sliding metal gate noted in O&M manual. Concrete structure located on both WS and landside (LS). Inspector noticed that during 2015-2016 that this crossing is used in the spring and summer, and buried in the winter. O&M manual structure reference is 4'-9" x 9'-6" concrete box culvert. (Automatic Board Order (ABO) issued as Permit No. 9482-1974, Elizabeth M. Farnsworth) [Additional Reference(s): DWR Levee Log, 1992. USACE Sacramento O&M Manual 137, August 1955, (Station 370+90)].

Overview of levee crown looking downstream at crossing.

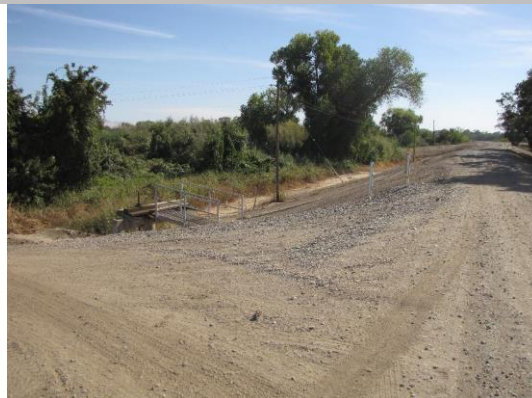
Photo 2 of 3 : UCIP_FA_2018_51876_70193.jpg

6/23/2014 Same as last inspection. Soli dug out again and water flowing through crossing.12/17/2013 WS screw gate was closed and buried by soil again.7/18/2013 WS screw gate has been cleared of dirt and is open to irrigate LS fields. LS outlet is still mostly blocked by sediment.10/19/2012 Structure is buried and non-operational. This crossing was listed in the USACE Periodic Inspection as ID# USACE_CESPK_MA1C_2010_p_0288 for sluice gate closed and backfilled on WS and full of sediment with wingwall cracked on LS. FIELD_STRUCT_DESC: 2 of 2: 36-inch reinforced concrete irrigation pipe through the levee, approximately 18 feet below the crown. Wooden slide gates on the waterside (WS) end. Sliding metal gate noted in O&M manual. Concrete structure located on both WS and landside (LS). Inspector noticed that during 2015-2016 that this crossing is used in the spring and summer, and buried in the winter. O&M manual structure reference is 4'-9" x 9'-6" concrete box culvert. (Automatic Board Order (ABO) issued as Permit No. 9482-1974, Elizabeth M. Farnsworth) [Additional Reference(s): DWR Levee Log, 1992. USACE Sacramento O&M Manual 137, August 1955, (Station 370+90)]. FS Date: 5/23/2017 10:15:43 AM

WS-walkway and concrete headwall.

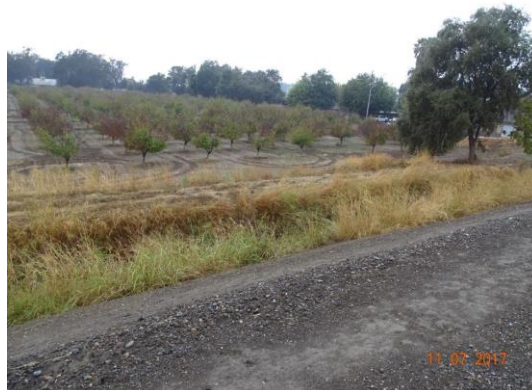
Photo 1 of 1 : FA_2018_MA0001_297_82_20180905_00019.jpg

LM Start	7.20	Rating **	U	Issue No.	82
LM End	7.26	Issue Type +	En	Location *	LS
Category	Earthen Levee			GPS Latitude/Longitude	
				Start	End
Item	Encroachments			39.293151 °	39.294042 °
				-122.021356 °	-122.021449 °
DWR ID	DWR_MA0001_01_s_2016_82				
Comment Code					
DT : Ditch					
Inspector Comment

View of the ditch along the landside toe.

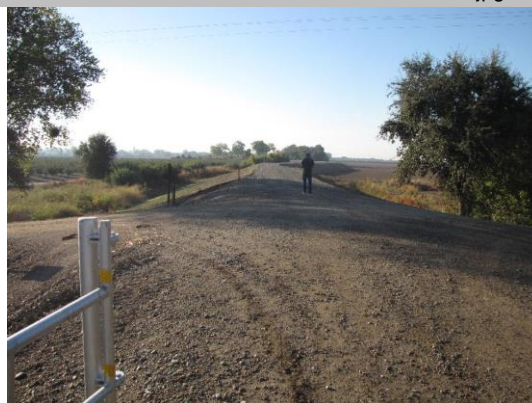
Photo 1 of 3 : UCIP_FA_2018_51877_70202.jpg

Comment Code					
Inspector Comment					
FS_ID:51877 DS_ID:16456 EP_NO: N/A Repair Type: Non-Urgent Crossing Status: Found UCIP Comments: 5/3/2017 Culvert was flowing water during site visit. Appears to be in good condition. Some sediment build up in the bottom of WS box. (DWR Sutter Yard- AFreitag)10/24/2016 Notes mentioned needing to confirm size of the culvert but was unable to access the ends at this inspection.(DWR Sutter Yard- AFreitag)4/25/2016 Second slide gate was held open to allow water to flow through to the LS ditch.4/20/2015 Same as last inspection. Rebar pin was still in place holding the gate opened.6/23/2014 Same as last inspection.12/17/2013 Same as last inspection.7/18/2013 Same as last inspection.10/30/2012 Sediment and debris on waterward and landward side. This crossing was listed in the USACE Periodic Inspection as ID# USACE_CESPK_MA1C_2010_p_0293 for wooden slide gate held open by a piece of rebar acting as a pin. FIELD_STRUCT_DESC: 60-inches by 72-inches (5-foot by 6-foot) reinforced concrete box irrigation culvert (O&M manual references 3-foot and 10-inch by 6-foot culvert) through the levee, approximately 12-15 feet below the crown. Two wooden slide gates on the waterside (WS) end. Concrete v-ditch along landside (LS) toe. [Additional Reference(s): DWR Levee Log, 1992. USACE Sacramento O&M Manual 137, August 1955, (Station 385+33.5)]. FS Date: 5/23/2017 10:27:11 AM

Overview of levee crown looking downstream at crossing.

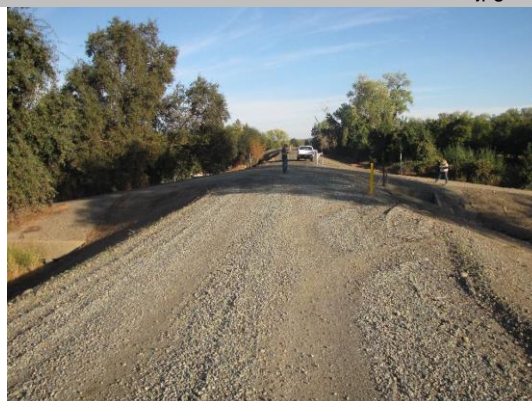
Photo 2 of 3 : UCIP_FA_2018_51877_70204.jpg

Comment Code						
Inspector Comment						
FS_ID:51877 DS_ID:16456 EP_NO: N/A Repair Type: Non-Urgent Crossing Status: Found UCIP Comments: 5/3/2017 Culvert was flowing water during site visit. Appears to be in good condition. Some sediment build up in the bottom of WS box. (DWR Sutter Yard- AFreitag)10/24/2016 Notes mentioned needing to confirm size of the culvert but was unable to access the ends at this inspection.(DWR Sutter Yard- AFreitag)4/25/2016 Second slide gate was held open to allow water to flow through to the LS ditch.4/20/2015 Same as last inspection. Rebar pin was still in place holding the gate opened.6/23/2014 Same as last inspection.12/17/2013 Same as last inspection.7/18/2013 Same as last inspection.10/30/2012 Sediment and debris on waterward and landward side. This crossing was listed in the USACE Periodic Inspection as ID# USACE_CESPK_MA1C_2010_p_0293 for wooden slide gate held open by a piece of rebar acting as a pin. FIELD_STRUCT_DESC: 60-inches by 72-inches (5-foot by 6-foot) reinforced concrete box irrigation culvert (O&M manual references 3-foot and 10-inch by 6-foot culvert) through the levee, approximately 12-15 feet below the crown. Two wooden slide gates on the waterside (WS) end. Concrete v-ditch along landside (LS) toe. [Additional Reference(s): DWR Levee Log, 1992. USACE Sacramento O&M Manual 137, August 1955, (Station 385+33.5)]. FS Date: 5/23/2017 10:27:11 AM

Overview of levee crown looking upstream at crossing.

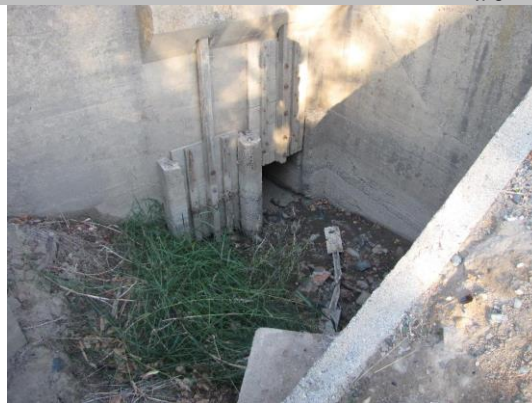
Photo 3 of 3 : UCIP_FA_2018_51877_70203.jpg

View of wooden sluice gates located on WS.

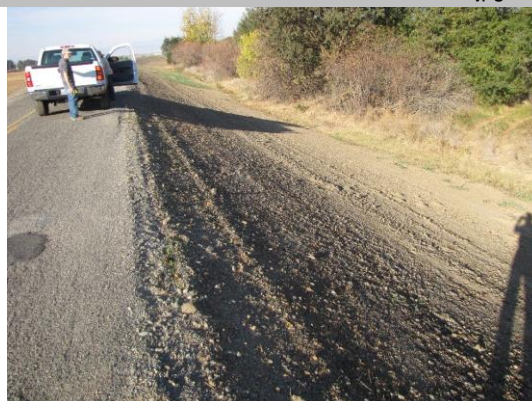
Photo 1 of 3 : UCIP_FA_2018_51878_70209.jpg

Comment Code						
Inspector Comment						
FS_ID:51878						
DS_ID:16455						
EP_NO: 12334						
Repair Type: Non-Urgent						
Crossing Status: Found						
UCIP Comments: 5/3/2017 No LS inlet found and no pump on WS- appears to have been abandoned. If so needs to be done properly. (DWR Sutter Yard- A Freitag)10/24/2016 Pump removed from WS pipe. Pipe end left open and should be capped.(DWR Sutter Yard- A Freitag)4/25/2016 No LS inlet found4/20/2015 Same as last inspection.6/23/2014 Same as last inspection.12/17/2013 Same as last inspection.7/18/2013 Same as last inspection.10/30/2012 Siphon breaker housing unit is bent and has debris inside. LS outlet not found.						
FIELD_STRUCT_DESC: 10-inch asphalt coated steel irrigation pipe through the levee, 3 feet below the crown. Centrifugal pump on the waterside (WS) bank. Siphon breaker on the landside (LS) shoulder of the levee. (Permit No. 12334, 1978 - Jean James) [Additional Reference(s): DWR Levee Log, 1992].

View of WS-no features on levee shoulder or slope.

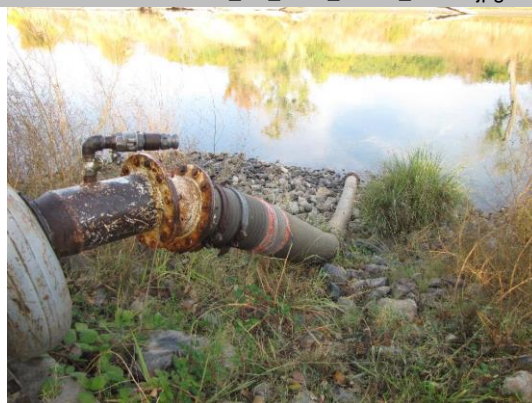
Photo 2 of 3 : UCIP_FA_2018_51878_70210.jpg

Pump located on WS bank.

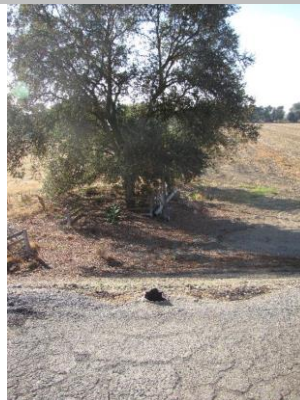
Photo 3 of 3 : UCIP_FA_2018_51878_70211.jpg

Comment Code						
Inspector Comment						
FS_ID:51878 DS_ID:16455 EP_NO: 12334 Repair Type: Non-Urgent Crossing Status: Found UCIP Comments: 5/3/2017 No LS inlet found and no pump on WS- appears to have been abandoned. If so needs to be done properly. (DWR Sutter Yard- A Freitag)10/24/2016 Pump removed from WS pipe. Pipe end left open and should be capped.(DWR Sutter Yard- A Freitag)4/25/2016 No LS inlet found4/20/2015 Same as last inspection.6/23/2014 Same as last inspection.12/17/2013 Same as last inspection.7/18/2013 Same as last inspection.10/30/2012 Siphon breaker housing unit is bent and has debris inside. LS outlet not found. FIELD_STRUCT_DESC: 10-inch asphalt coated steel irrigation pipe through the levee, 3 feet below the crown. Centrifugal pump on the waterside (WS) bank. Siphon breaker on the landside (LS) shoulder of the levee. (Permit No. 12334, 1978 - Jean James) [Additional Reference(s): DWR Levee Log, 1992]. FS Date: 5/23/2017 10:29:58 AM

View of LS with appurtenances present on levee shoulder.

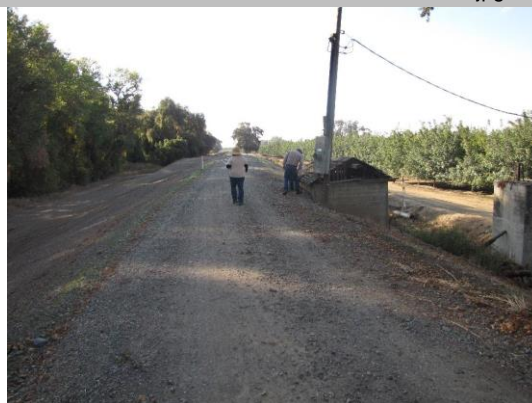
Photo 1 of 3 : UCIP_FA_2018_51879_70219.jpg

Comment Code					
Inspector Comment					
FS_ID:51879 DS_ID:16454 EP_NO: 9466 Repair Type: Non-Urgent Crossing Status: Found UCIP Comments: 5/3/2017 Abandoned- needs to be done properly. (DWR Sutter Yard- A Freitag)10/24/2016 Abandoned.(DWR Sutter Yard- A Freitag)4/25/2016 Crossing appears to be abandoned. Power lines cut from the panels inside the concrete structure on LS.4/20/2015 Same as last inspection.6/23/2014 Same as last inspection.12/17/2013 Same as last inspection.7/18/2013 Same as last inspection.10/30/2012 No access to inspect slide gate on LS. Roof of pumping house deteriorating and debris scattered on LS. WS crossing not found. This crossing was listed in the USACE Periodic Inspection as ID# USACE_CESPK_MA1C_2010_p_345 no issues recorded. FIELD_STRUCT_DESC: *ABANDONED* 24-inch steel irrigation pipe through the levee, approximately 8-10 feet below the crown. Slide gate in concrete riser on the landside (LS) slope. Pump house encroaches into the LS slope. Two service poles on the LS shoulder. No visible appurtenances found on the waterside (WS) toe. Power source cut on the LS. (Automatic Board Order (ABO) issued as Permit No. 9466, 1974 - Roman Catholic Bishop of Sacramento). [Additional Reference(s): DWR Levee Log, 1992]. FS Date: 5/23/2017 10:31:07 AM

Overview of levee crown looking downstream at crossing.

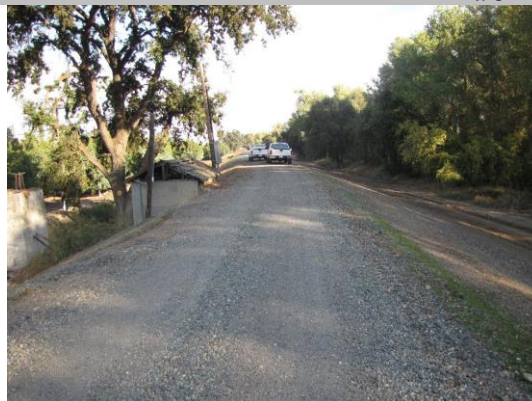
Photo 2 of 3 : UCIP_FA_2018_51879_70217.jpg

Overview of levee crown looking upstream at crossing.

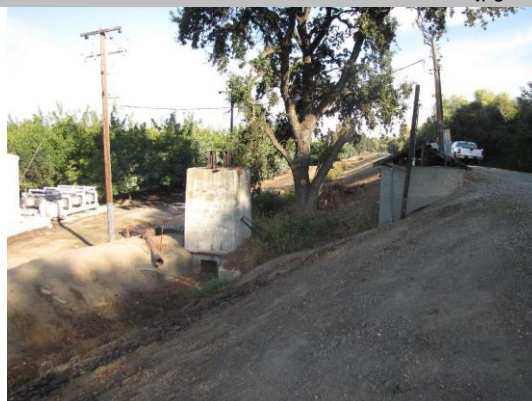
Photo 3 of 3 : UCIP_FA_2018_51879_70218.jpg

Comment Code						
Inspector Comment						
FS_ID:51879						
DS_ID:16454						
EP_NO: 9466						
Repair Type: Non-Urgent						
Crossing Status: Found						
UCIP Comments: 5/3/2017 Abandoned- needs to be done properly.						
(DWR Sutter Yard- A Freitag)10/24/2016 Abandoned.(DWR Sutter						
Yard- A Freitag)4/25/2016 Crossing appears to be abandoned. Power						
lines cut from the panels inside the concrete structure on						
LS.4/20/2015 Same as last inspection.6/23/2014 Same as last						
inspection.12/17/2013 Same as last inspection.7/18/2013 Same as						
last inspection.10/30/2012 No access to inspect slide gate on LS.						
Roof of pumping house deteriorating and debris scattered on LS. WS						
crossing not found. This crossing was listed in the USACE Periodic						
Inspection as ID# USACE_CESPK_MA1C_2010_p_345 no issues						
recorded.						
FIELD_STRUCT_DESC: *ABANDONED* 24-inch steel irrigation pipe

through the levee, approximately 8-10 feet below the crown. Slide gate						
in concrete riser on the landside (LS) slope. Pump house encroaches						
into the LS slope. Two service poles on the LS shoulder. No visible						
appurtenances found on the waterside (WS) toe. Power source cut on						
the LS. (Automatic Board Order (ABO) issued as Permit No. 9466,						
1974 - Roman Catholic Bishop of Sacramento). [Additional						
Reference(s): DWR Levee Log, 1992].						
FS Date: 5/23/2017 10:31:07 AM

View of pump and standpipe located on LS.

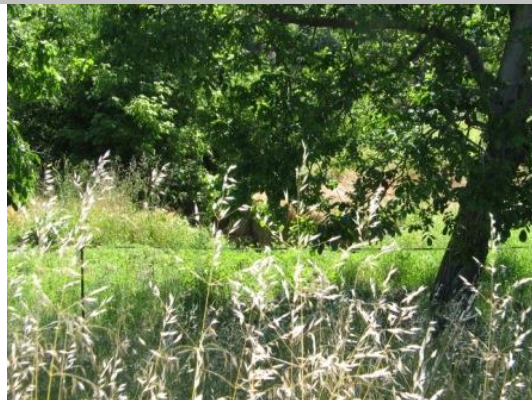
Photo 1 of 1 : FA_2018_MA0001_297_18_20180905_00009.jpg

LM Start	10.13	Rating **	M	Issue No.	18
LM End	10.13	Issue Type +	Ma	Location *	WS
Category	Earthen Levee			GPS Latitude/Longitude	
				Start	End
Item	Erosion / Bank Caving			39.328697 °	39.328697 °
				-122.029262 °	-122.029262 °
DWR ID	DWR_MA0001_01_s_2012_18				
Comment Code					
E1 : Note and monitor erosion site.					
Inspector Comment					
Monitor the erosion site.

View of the erosion along the waterside of the levee.

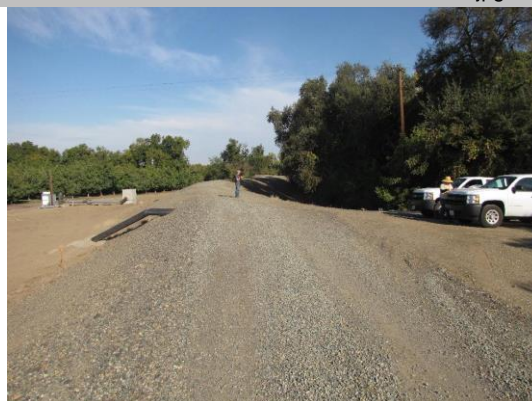
Photo 1 of 3 : UCIP_FA_2018_53050_70236.jpg

FS_ID:53050
DS_ID:16452
EP_NO: 1800
Repair Type: Non-Urgent
Crossing Status: Found
UCIP Comments: 10/1/2018 Runoff erosion near pipe on WS is present. Pipe is in good condition. Need to verify new permit for the pipe. (O.Yakimov - DWR)5/3/2017 Rain run off erosion still present near pipe on WS shoulder. (DWR Sutter Yard- AFreitag)10/24/2016 Ws erosion still present. Looks to be just from rain run off.(DWR Sutter Yard- AFreitag)4/25/2016 Erosion still present by the WS pipes. (DWR Sutter Yard - afreitag)4/20/2015 Erosion happening near WS shoulder where the pipes enter the levee. May just be caused by rain runoff. (DWR Sutter Yard - afreitag)6/23/2014 Same as last inspection. (DWR Sutter Yard - afreitag)12/17/2013 Same as last inspection. (DWR Sutter Yard - afreitag)7/18/2013 Same as last inspection. (DWR Sutter Yard - afreitag)10/30/2012 This crossing has been completely modified--need recent permit issued to allow work on levee and levee toe. Was levee compacted to CVFPB standards? This crossing was listed in the USACE Periodic Inspection as ID# USACE_CESPK_MA1C_2010_p_0371 unable to determine why this crossing was assigned "U". (DWR UCIP - omagana)

Overview of levee crown looking upstream at crossing.

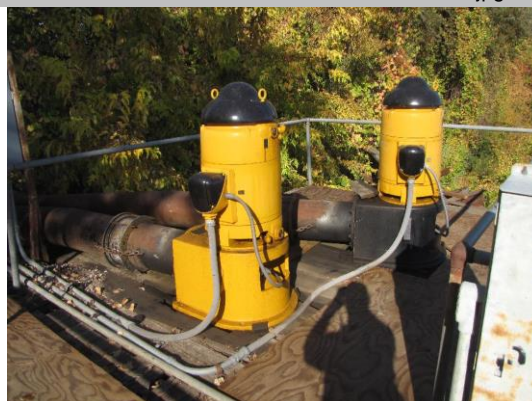
Photo 2 of 3 : UCIP_FA_2018_53050_70239.jpg

FS_ID:53050
DS_ID:16452
EP_NO: 1800
Repair Type: Non-Urgent
Crossing Status: Found
UCIP Comments: 10/1/2018 Runoff erosion near pipe on WS is present. Pipe is in good condition. Need to verify new permit for the pipe. (O.Yakimov - DWR)5/3/2017 Rain run off erosion still present near pipe on WS shoulder. (DWR Sutter Yard- AFreitag)10/24/2016 Ws erosion still present. Looks to be just from rain run off.(DWR Sutter Yard- AFreitag)4/25/2016 Erosion still present by the WS pipes. (DWR Sutter Yard - afreitag)4/20/2015 Erosion happening near WS shoulder where the pipes enter the levee. May just be caused by rain runoff. (DWR Sutter Yard - afreitag)6/23/2014 Same as last inspection. (DWR Sutter Yard - afreitag)12/17/2013 Same as last inspection. (DWR Sutter Yard - afreitag)7/18/2013 Same as last inspection. (DWR Sutter Yard - afreitag)10/30/2012 This crossing has been completely modified--need recent permit issued to allow work on levee and levee toe. Was levee compacted to CVFPB standards? This crossing was listed in the USACE Periodic Inspection as ID# USACE_CESPK_MA1C_2010_p_0371 unable to determine why this crossing was assigned "U". (DWR UCIP - omagana)

Pumps corresponding to 2-14 inch pipes.

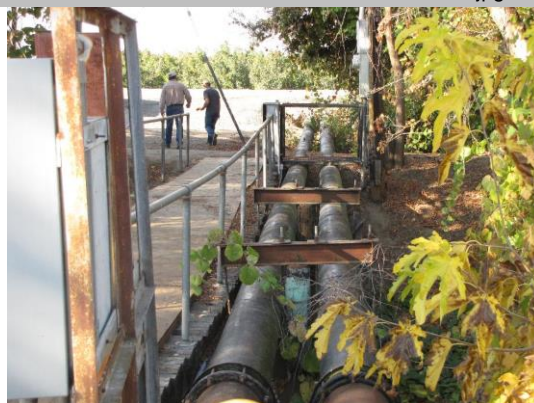
Photo 3 of 3 : UCIP_FA_2018_53050_70238.jpg

FS_ID:53050
DS_ID:16452
EP_NO: 1800
Repair Type: Non-Urgent
Crossing Status: Found
UCIP Comments: 10/1/2018 Runoff erosion near pipe on WS is present. Pipe is in good condition. Need to verify new permit for the pipe. (O.Yakimov - DWR)5/3/2017 Rain run off erosion still present near pipe on WS shoulder. (DWR Sutter Yard- AFreitag)10/24/2016 Ws erosion still present. Looks to be just from rain run off.(DWR Sutter Yard- AFreitag)4/25/2016 Erosion still present by the WS pipes. (DWR Sutter Yard - afreitag)4/20/2015 Erosion happening near WS shoulder where the pipes enter the levee. May just be caused by rain runoff. (DWR Sutter Yard - afreitag)6/23/2014 Same as last inspection. (DWR Sutter Yard - afreitag)12/17/2013 Same as last inspection. (DWR Sutter Yard - afreitag)7/18/2013 Same as last inspection. (DWR Sutter Yard - afreitag)10/30/2012 This crossing has been completely modified--need recent permit issued to allow work on levee and levee toe. Was levee compacted to CVFPB standards? This crossing was listed in the USACE Periodic Inspection as ID# USACE_CESPK_MA1C_2010_p_0371 unable to determine why this crossing was assigned "U". (DWR UCIP - omagana)

WS-2-14 inch pipes parallel catwalk and go through levee.

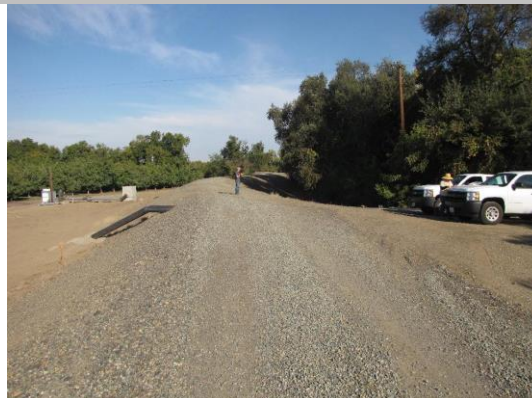
Photo 1 of 3 : UCIP_FA_2018_53051_70228.jpg

FS_ID:53051
DS_ID:17571
EP_NO: 1800
Repair Type: Non-Urgent
Crossing Status: Found
UCIP Comments: 10/1/2018 Runoff erosion near pipe on WS is present. Pipe is in good condition. Need to verify new permit for the pipe. (O.Yakimov - DWR)5/3/2017 Rain runoff erosion still present near pipes on WS shoulder. (DWR Sutter Yard- AFreitag)10/24/2016 Ws erosion still present. Looks to be just from rain run off.(DWR Sutter Yard- AFreitag)4/25/2016 Erosion still present near the WS pipes. (DWR Sutter Yard - afreitag)4/20/2015 Erosion happening on WS shoulder near where pipes enter the levee. May just be from rain runoff. (DWR Sutter Yard - afreitag)6/23/2014 Same as last inspection. (DWR Sutter Yard - afreitag)12/17/2013 Same as last inspection. (DWR Sutter Yard - afreitag)7/18/2013 Same as last inspection. (DWR Sutter Yard - afreitag)10/30/2012 This crossing has been completely modified--need recent permit issued to allow work on levee and levee toe. Was levee compacted to CVFPB standards? This crossing was listed in the USACE Periodic Inspection as ID# USACE_CESPK_MA1C_2010_p_0371 unable to determine why this crossing was assigned "U". (DWR UCIP - omagana)

Overview of levee crown looking upstream at crossing.

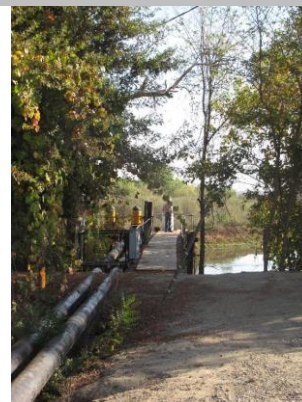
Photo 2 of 3 : UCIP_FA_2018_53051_70226.jpg

View of catwalk and pump station located on WS.

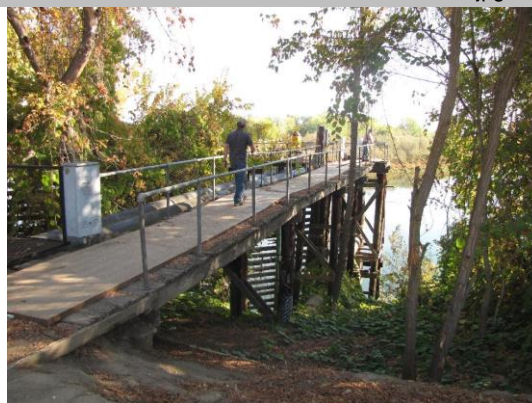
Photo 3 of 3 : UCIP_FA_2018_53051_70232.jpg

Item	DWR UCIP Field Study			39.329750 °	39.329750 °	
				-122.029602 °	-122.029602 °	
DWR ID	17571					
Comment Code						
Inspector Comment						
FS_ID:53051 DS_ID:17571 EP_NO: 1800 Repair Type: Non-Urgent Crossing Status: Found UCIP Comments: 10/1/2018 Runoff erosion near pipe on WS is present. Pipe is in good condition. Need to verify new permit for the pipe. (O.Yakimov - DWR)5/3/2017 Rain runoff erosion still present near pipes on WS shoulder. (DWR Sutter Yard- AFreitag)10/24/2016 Ws erosion still present. Looks to be just from rain run off.(DWR Sutter Yard- AFreitag)4/25/2016 Erosion still present near the WS pipes. (DWR Sutter Yard - afreitag)4/20/2015 Erosion happening on WS shoulder near where pipes enter the levee. May just be from rain runoff. (DWR Sutter Yard - afreitag)6/23/2014 Same as last inspection. (DWR Sutter Yard - afreitag)12/17/2013 Same as last inspection. (DWR Sutter Yard - afreitag)7/18/2013 Same as last inspection. (DWR Sutter Yard - afreitag)10/30/2012 This crossing has been completely modified--need recent permit issued to allow work on levee and levee toe. Was levee compacted to CVFPB standards? This crossing was listed in the USACE Periodic Inspection as ID# USACE_CESPK_MA1C_2010_p_0371 unable to determine why this crossing was assigned "U". (DWR UCIP - omagana) FIELD_STRUCT_DESC: 2 of 2: 14-inch steel irrigation pipe through the levee, approximately 3-4 feet below the crown. Siphon breaker located on the waterside (WS) end. (Permit No. 1800, 1959 - Jimeno Rancho) [Additional Reference(s): DWR Levee Log, 1992]. FS Date: 10/1/2018 3:18:33 PM

Close-up of catwalk, control panel, and pump station located on WS.

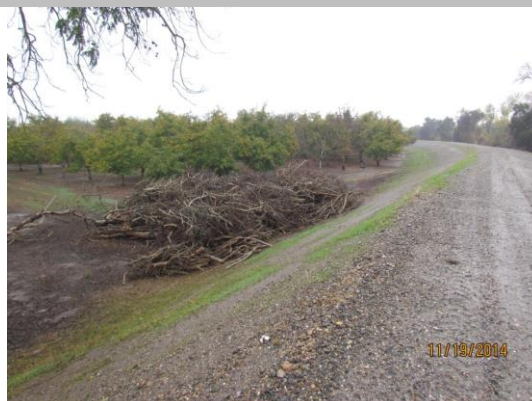
Photo 1 of 1 : FA_2018_MA0001_297_636_20180905_00042.jpg

LM Start	10.32	Rating **	M	Issue No.	636	
LM End	10.32	Issue Type +	En	Location *	LS	
Category	Earthen Levee			GPS Latitude/Longitude		
				Start	End	
Item	Encroachments			39.331320 °	39.331320 °	
				-122.029932 °	-122.029932 °	
DWR ID	DWR_MA0001_01_f_2014_636					
Comment Code						
PR : Prunings						
Inspector Comment						
Remove prunings from the landside toe.

View of the pruning along the landside toe.

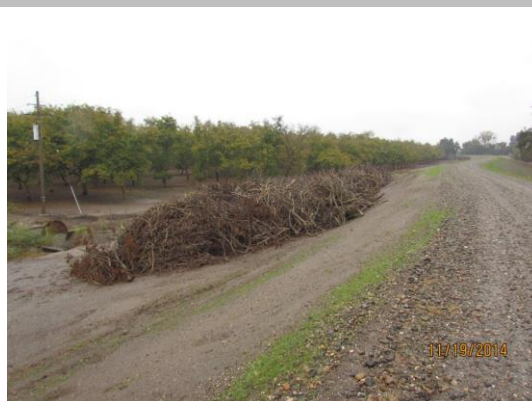
Photo 1 of 1 : FA_2018_MA0001_297_637_20180905_00043.jpg

LM Start	10.78	Rating **	M	Issue No.	637
LM End	10.78	Issue Type +	En	Location *	LS
Category	Earthen Levee			GPS Latitude/Longitude	
				Start	End
Item	Encroachments			39.337523 °	39.337523 °
				-122.032437 °	-122.032437 °
DWR ID	DWR_MA0001_01_f_2014_637				
Comment Code					
PR : Prunings					
Inspector Comment

View of the pruning along the landside toe.

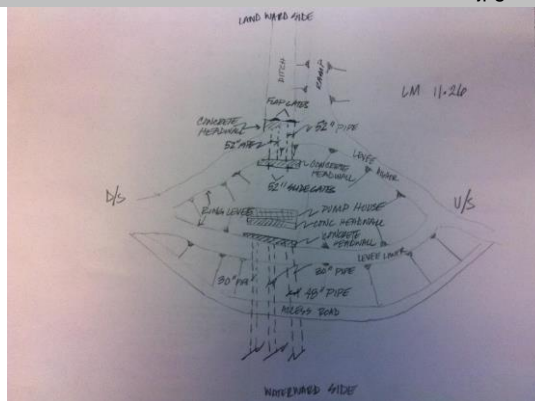
Photo 1 of 3 : UCIP_FA_2018_53053_70267.jpg

UCIP Comments: 10/1/2018 Pipe closed by steel plate at LS end. Plate is bolted to concrete headwall. CVFPB is working with owner to address issue. (O.Yakimov - DWR)5/3/2017 No changes have been made to this crossing since the NOV was sent out in January 2017. (DWR Sutter Yard- A Freitag)01/31/2017 Informal Notice of Violation (NOV) was sent out January 31, 2017 by DWR Flood Maintenance Office--owner will need to coordinate with CVFPB to remove, replace, or abandon pipe in-place. Owner has until Monday February 27th, 2017 to respond to DWR contact: Bryan Reniff. (refer to Official Notice for details). (DWR UCIP - O. Magana)10/24/2016 Appears abandoned. Slide gate needs to be dug out and fully closed to prevent water flow during high water.(DWR Sutter Yard- A Freitag)4/25/2016 Crossing appears to be abandoned.4/21/2015 Same as last inspection.6/23/2014 Same as last inspection.12/17/2013 Same as last inspection.7/18/2013 Same as last inspection.10/30/2012 Need to determine if structure is still in use--contact owner. If abandoned structure--structure needs to be properly abandoned. This crossing was listed in the USACE Periodic Inspections as ID#

USACE_CESPK_MA1C_2010_p_0393 missing gate.

Sketch of structure located at levee mile 11.26.

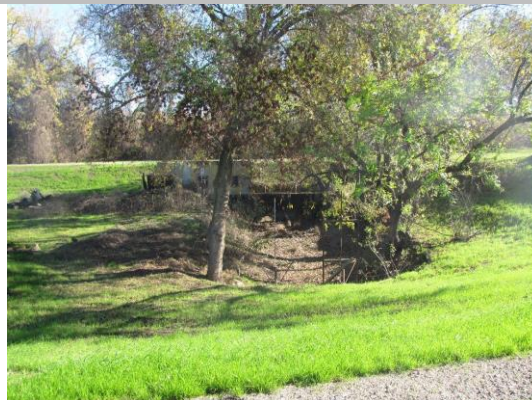
Photo 2 of 3 : UCIP_FA_2018_53053_70265.jpg

UCIP Comments: 10/1/2018 Pipe closed by steel plate at LS end. Plate is bolted to concrete headwall. CVFPB is working with owner to address issue. (O.Yakimov - DWR)5/3/2017 No changes have been made to this crossing since the NOV was sent out in January 2017. (DWR Sutter Yard- AFreitag)01/31/2017 Informal Notice of Violation (NOV) was sent out January 31, 2017 by DWR Flood Maintenance Office--owner will need to coordinate with CVFPB to remove, replace, or abandon pipe in-place. Owner has until Monday February 27th, 2017 to respond to DWR contact: Bryan Reniff. (refer to Official Notice for details). (DWR UCIP - O. Magana)10/24/2016 Appears abandoned. Slide gate needs to be dug out and fully closed to prevent water flow during high water.(DWR Sutter Yard- AFreitag)4/25/2016 Crossing appears to be abandoned.4/21/2015 Same as last inspection.6/23/2014 Same as last inspection.12/17/2013 Same as last inspection.7/18/2013 Same as last inspection.10/30/2012 Need to determine if structure is still in use--contact owner. If abandoned structure--structure needs to be properly abandoned. This crossing was listed in the USACE Periodic Inspections as ID# USACE_CESPK_MA1C_2010_p_0393 missing gate. FIELD_STRUCT_DESC: 1 of 2: 52-inch corrugated metal irrigation pipe, 48-inch measured, through the levee, approximately 15 feet below the crown. Slide gate on the waterside (WS) and flap gate on the landside (LS). Concrete headwalls at both WS and LS. This structure is associated with another abandoned structure located on the WS. Abandoned structure includes pump house, multiple concrete walls, and 3 additional crossings (two 30-inch pipes and one 48-inch pipe). (Original structure installed under Permit No. 187, 1921 - Compton-Delevan Irrigation District-Maxwell I.D., new pump and platform installed and old pump house removed under Permit No. 9183-1973, Maxwell Irrigation District) [Additional Reference(s): DWR Levee Log, 1992]. FS Date: 10/1/2018 3:42:41 PM

View of abandoned structure located on WS (inside ring levee).

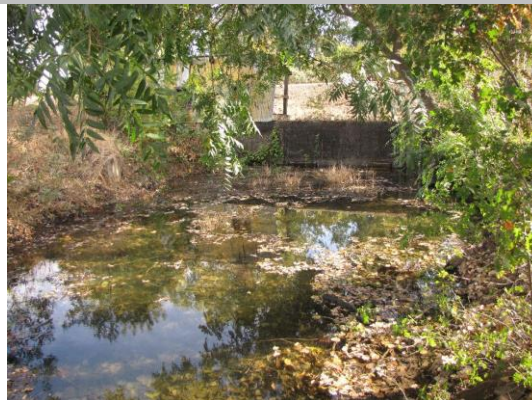
Photo 3 of 3 : UCIP_FA_2018_53053_70260.jpg

FS_ID:53053
DS_ID:16449
EP_NO: 187
Repair Type: Non-Urgent
Crossing Status: Found
UCIP Comments: 10/1/2018 Pipe closed by steel plate at LS end. Plate is bolted to concrete headwall. CVFPB is working with owner to address issue. (O.Yakimov - DWR)5/3/2017 No changes have been made to this crossing since the NOV was sent out in January 2017. (DWR Sutter Yard- AFreitag)01/31/2017 Informal Notice of Violation (NOV) was sent out January 31, 2017 by DWR Flood Maintenance Office--owner will need to coordinate with CVFPB to remove, replace, or abandon pipe in-place. Owner has until Monday February 27th, 2017 to respond to DWR contact: Bryan Reniff. (refer to Official Notice for details). (DWR UCIP - O. Magana)10/24/2016 Appears abandoned. Slide gate needs to be dug out and fully closed to prevent water flow during high water.(DWR Sutter Yard- AFreitag)4/25/2016 Crossing appears to be abandoned.4/21/2015 Same as last inspection.6/23/2014 Same as last inspection.12/17/2013 Same as last inspection.7/18/2013 Same as last inspection.10/30/2012 Need to determine if structure is still in use--contact owner. If abandoned structure--structure needs to be properly abandoned. This crossing was listed in the USACE Periodic Inspections as ID# USACE_CESPK_MA1C_2010_p_0393 missing gate.

Drain channel inside ring levee.

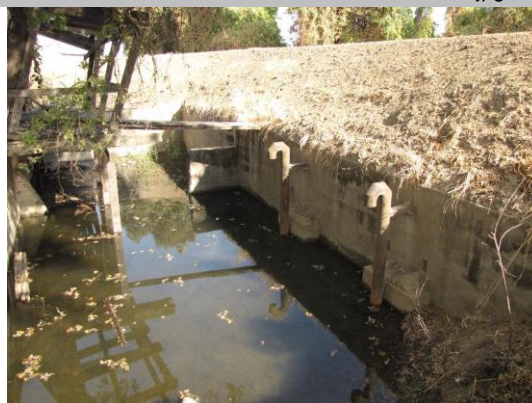
Photo 3 of 3 : UCIP_FA_2018_53052_70275.jpg

UCIP Comments: 10/1/2018 Pipe closed by steel plate at LS end. Plate is bolted to concrete headwall. CVFPB is working with owner to address issue. Crossing remains "Urgent" because of missing slide gate on WS. (O.Yakimov - DWR)5/3/2017 No changes have been made at this crossing since the NOV was sent out in January 2017. (DWR Sutter Yard- AFreitag)01/31/2017 Informal Notice of Violation (NOV) was sent out January 31, 2017 by DWR Flood Maintenance Office--owner will need to coordinate with CVFPB to remove, replace, or abandon pipe in-place. Owner has until Monday February 27th, 2017 to respond to DWR contact: Bryan Reniff. (refer to Official Notice for details). (DWR UCIP - O. Magana)10/24/2016 Appears abandoned. Slide gate needs to be replaced or pipe end capped to prevent water flow during high water. (DWR Sutter Yard- AFreitag)4/25/2016 Crossing appears to be abandoned. Slide gate needs to be replaced or pipe needs to be plugged to prevent water flow during high water season. (DWR Sutter Yard - afreitag)4/21/2015 Same as last inspection. (DWR Sutter Yard - afreitag)6/23/2014 Same as last inspection. (DWR Sutter Yard - afreitag)12/17/2013 Same as last inspection. (DWR Sutter Yard - afreitag)7/18/2013 Same as last inspection. (DWR Sutter Yard - afreitag)10/30/2012 Missing positive closure device. Need to determine if structure is still in use--contact owner. If abandoned structure--structure needs to be abandoned properly. This crossing was listed in the USACE Periodic Inspections as ID#

USACE_CESPK_MA1C_2010_p_0393 missing gate. (DWR UCIP - omagana)

WS-Concrete headwall with multiple crossings (2-30 inch pipes and 1-48 inch pipe).

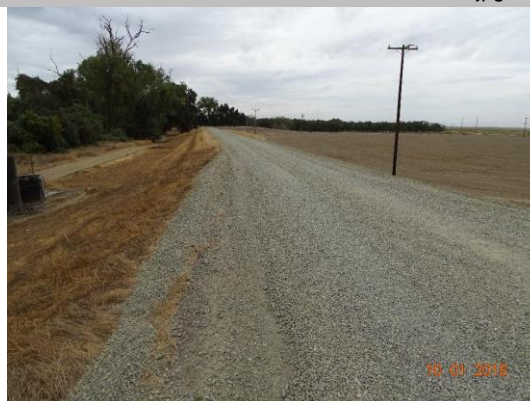
Photo 1 of 3 : UCIP_FA_2018_53054_78258.jpg

Comment Code					
Inspector Comment					
FS_ID:53054 DS_ID:17691 EP_NO: 17471 Repair Type: Urgent Crossing Status: Found UCIP Comments: 10/1/2018 Sink hole between CMP risers on WS has grown. Need to contact owner to address issue. Recommend video inspection. (O.Yakimov - DWR)5/3/2017 Sink hole still present between the WS risers. It does not appears to be getting worse. Pumps were running during site visit but the sink hole was dry this time. (DWR Sutter Yard- AFreitag)10/24/2016 Sinkhole still present.(DWR Sutter Yard- AFreitag)4/25/2016 Sink hole between the standpipes seems to be getting worse. Measurements of the hole are 3' wide x 3' long x 3' deep. The pipe was flowing water and there was water present in the bottom of the sink hole. (DWR Sutter Yard - afreitag)4/21/2015 Sink hole still present between risers. (DWR Sutter Yard - afreitag)6/23/2014 Standing water was present in the bottom of the sinkhole. (DWR Sutter Yard - afreitag)12/17/2013 Same as last inspection. (DWR Sutter Yard - afreitag)7/18/2013 Same as last inspection. (DWR Sutter Yard - afreitag)10/30/2012 Erosion between risers with slide gates located on waterward side; This crossing was listed in the USACE Periodic Inspections as ID# USACE_CESPK_MA1C_2010_p_0398 for possible sinkhole between access gate structures. (DWR UCIP - omagana) FIELD_STRUCT_DESC: 1 of 2: 24-inch high-density polyethylene (HDPE) irrigation pipe to be connected to the existing corrugated metal pipe (CMP) riser within the waterside (WS) and parallel to the right (west) bank levee of the Sacramento River. (Permit 17471, 2002 - Maxwell Irrigation District). FS Date: 10/1/2018 3:53:48 PM

View of levee crown at crossing.

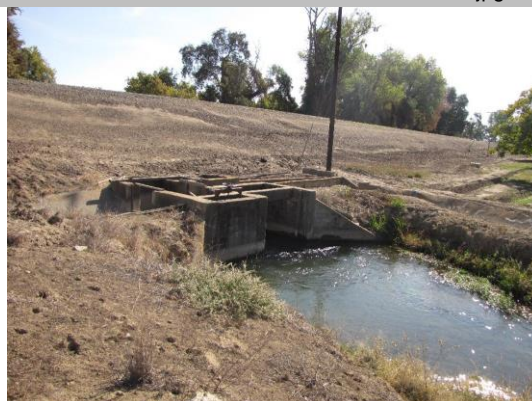
Photo 2 of 3 : UCIP_FA_2018_53054_70326.jpg

Item	DWR UCIP Field Study			39.343263 °	39.343263 °	
				-122.032152 °	-122.032152 °	
DWR ID	17691					
Comment Code						
Inspector Comment						
FS_ID:53054 DS_ID:17691 EP_NO: 17471 Repair Type: Urgent Crossing Status: Found UCIP Comments: 10/1/2018 Sink hole between CMP risers on WS has grown. Need to contact owner to address issue. Recommend video inspection. (O.Yakimov - DWR)5/3/2017 Sink hole still present between the WS risers. It does not appears to be getting worse. Pumps were running during site visit but the sink hole was dry this time. (DWR Sutter Yard- AFreitag)10/24/2016 Sinkhole still present.(DWR Sutter Yard- AFreitag)4/25/2016 Sink hole between the standpipes seems to be getting worse. Measurements of the hole are 3' wide x 3' long x 3' deep. The pipe was flowing water and there was water present in the bottom of the sink hole. (DWR Sutter Yard - afreitag)4/21/2015 Sink hole still present between risers. (DWR Sutter Yard - afreitag)6/23/2014 Standing water was present in the bottom of the sinkhole. (DWR Sutter Yard - afreitag)12/17/2013 Same as last inspection. (DWR Sutter Yard - afreitag)7/18/2013 Same as last inspection. (DWR Sutter Yard - afreitag)10/30/2012 Erosion between risers with slide gates located on waterward side; This crossing was listed in the USACE Periodic Inspections as ID# USACE_CESPK_MA1C_2010_p_0398 for possible sinkhole between access gate structures. (DWR UCIP - omagana) FIELD_STRUCT_DESC: 1 of 2: 24-inch high-density polyethylene (HDPE) irrigation pipe to be connected to the existing corrugated metal pipe (CMP) riser within the waterside (WS) and parallel to the right (west) bank levee of the Sacramento River. (Permit 17471, 2002 - Maxwell Irrigation District). FS Date: 10/1/2018 3:53:48 PM

View of concrete distribution box located on LS toe.

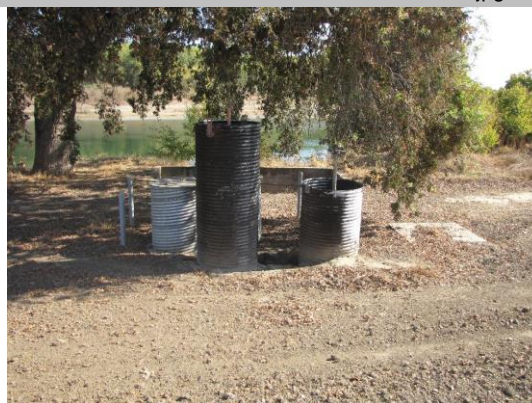
Photo 3 of 3 : UCIP_FA_2018_53054_70330.jpg

Item	DWR UCIP Field Study			39.343263 °	39.343263 °	
				-122.032152 °	-122.032152 °	
DWR ID	17691					
Comment Code						
Inspector Comment						
FS_ID:53054 DS_ID:17691 EP_NO: 17471 Repair Type: Urgent Crossing Status: Found UCIP Comments: 10/1/2018 Sink hole between CMP risers on WS has grown. Need to contact owner to address issue. Recommend video inspection. (O.Yakimov - DWR)5/3/2017 Sink hole still present between the WS risers. It does not appears to be getting worse. Pumps were running during site visit but the sink hole was dry this time. (DWR Sutter Yard- AFreitag)10/24/2016 Sinkhole still present.(DWR Sutter Yard- AFreitag)4/25/2016 Sink hole between the standpipes seems to be getting worse. Measurements of the hole are 3' wide x 3' long x 3' deep. The pipe was flowing water and there was water present in the bottom of the sink hole. (DWR Sutter Yard - afreitag)4/21/2015 Sink hole still present between risers. (DWR Sutter Yard - afreitag)6/23/2014 Standing water was present in the bottom of the sinkhole. (DWR Sutter Yard - afreitag)12/17/2013 Same as last inspection. (DWR Sutter Yard - afreitag)7/18/2013 Same as last inspection. (DWR Sutter Yard - afreitag)10/30/2012 Erosion between risers with slide gates located on waterward side; This crossing was listed in the USACE Periodic Inspections as ID# USACE_CESPK_MA1C_2010_p_0398 for possible sinkhole between access gate structures. (DWR UCIP - omagana) FIELD_STRUCT_DESC: 1 of 2: 24-inch high-density polyethylene (HDPE) irrigation pipe to be connected to the existing corrugated metal pipe (CMP) riser within the waterside (WS) and parallel to the right (west) bank levee of the Sacramento River. (Permit 17471, 2002 - Maxwell Irrigation District). FS Date: 10/1/2018 3:53:48 PM

CMP risers located on WS berm. 18-inch pipe corresponds to downstream riser with slide gate. 24-inch pipe corresponds to upstream riser with slide gate.

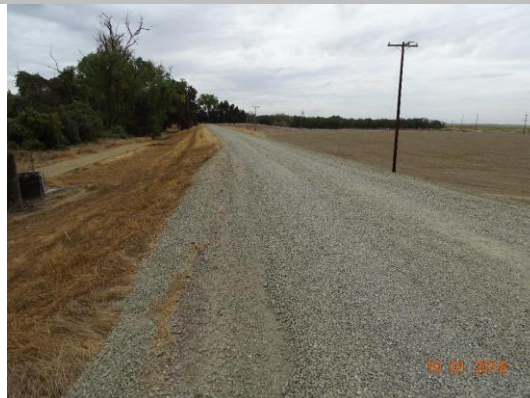
Photo 1 of 3 : UCIP_FA_2018_53056_78261.jpg

View of levee crown at crossing.

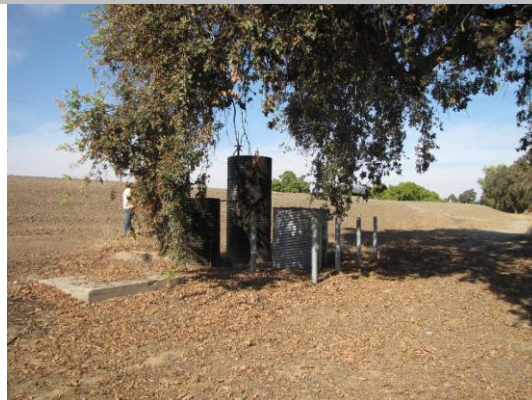
Photo 3 of 3 : UCIP_FA_2018_53056_70323.jpg

UCIP Comments: 10/1/2018 Sink hole between CMP risers on WS has grown. Need to contact owner to address issue. Recommend video inspection. (O.Yakimov - DWR)5/3/2017 Sink hole still present between the WS risers. It does not appears to be getting worse.

View of CMP risers located on WS berm.

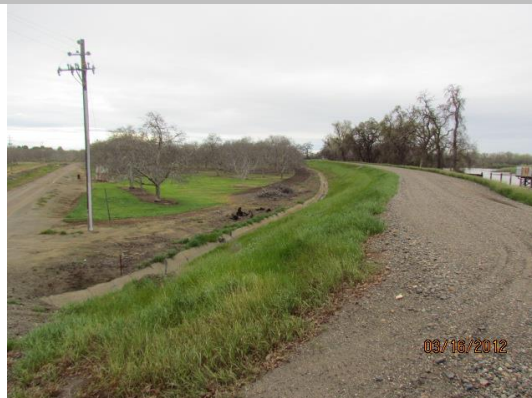
Photo 1 of 1 : FA_2018_MA0001_297_27_20180905_00013.jpg

LM Start	11.21	Rating **	M	Issue No.	27
LM End	11.46	Issue Type +	En	Location *	LS
Category	Earthen Levee			GPS Latitude/Longitude	
				Start	End
Item	Encroachments			39.343542 °	39.347185 °
				-122.032107 °	-122.031525 °
DWR ID	DWR_MA0001_01_s_2012_27				
Comment Code					
DT : Ditch					
Inspector Comment

View of the ag. ditch along the landside toe.

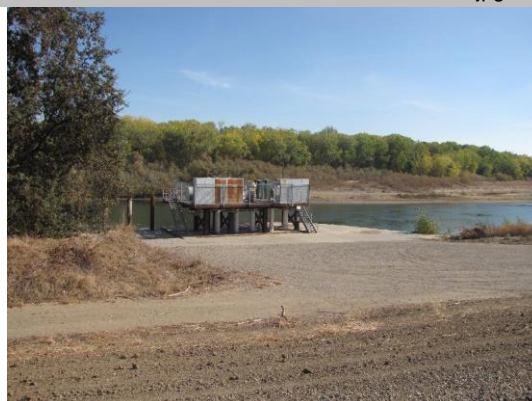
Photo 2 of 3 : UCIP_FA_2018_51900_70343.jpg

Item	DWR UCIP Field Study			39.344400 °	39.344400 °	
				-122.031785 °	-122.031785 °	
DWR ID	20584					
Comment Code						
Inspector Comment						
FS_ID:51900 DS_ID:20584 EP_NO: N/A Repair Type: Non-Urgent Crossing Status: Found UCIP Comments: 5/3/2017 Crossing appears to be in good condition. (DWR Sutter Yard- A Freitag)10/24/2016 appears to be in good condition.(DWR Sutter Yard- A Freitag)4/25/2016 Crossing appears to be in good condition.4/21/2015 Same as last inspection.6/23/2014 Same as last inspection.12/17/2013 Same as last inspection.7/22/2013 Same as last inspection.10/30/2012 Need to determine encroachment permit for this crossing. FIELD_STRUCT_DESC: [Maxwell Irrigation District] 3 of 3: 24-inch steel irrigation pipe through the levee at an unknown depth below the crown. Crossing is tied to existing Maxwell Irrigation District Pump Station located on the waterside (WS). Siphon breaker inside corrugated metal pipe (CMP) riser located on the landside (LS) shoulder. No permit has been identified since crossing was field discovered in 2012. FS Date: 5/23/2017 11:47:50 AM

Maxwell Irrigation District Pump Station located on WS.

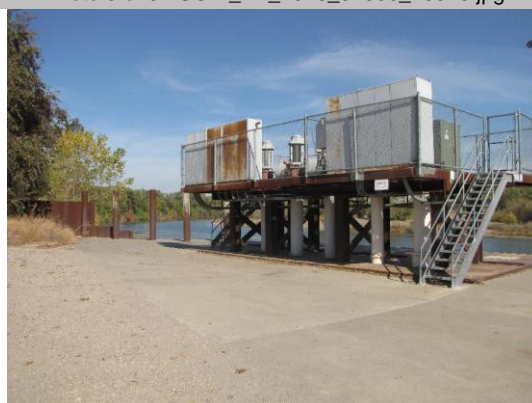
Photo 3 of 3 : UCIP_FA_2018_51900_70345.jpg

Maxwell Irrigation District Pump Station located on WS.

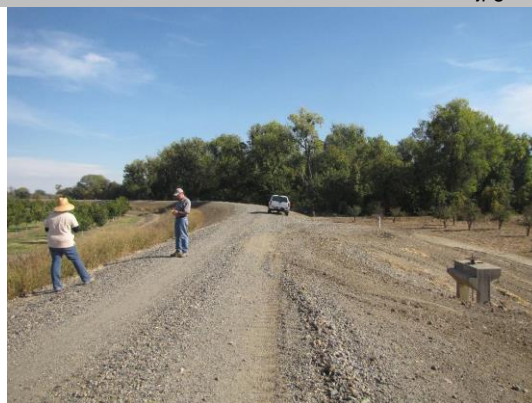
Photo 1 of 3 : UCIP_FA_2018_51903_70352.jpg

Comment Code						
Inspector Comment						
FS_ID:51903 DS_ID:16445 EP_NO: 9462 Repair Type: Non-Urgent Crossing Status: Found UCIP Comments: 5/3/2017 Appears abandoned- needs to be done properly.(DWR Sutter Yard- AFreitag)10/24/2016 Appears abandoned. LS concrete canal is filled by pipe DSID 16444.4/25/2016 Appears to be an abandoned crossing. WS slide gate still buried and inoperable.4/21/2015 Same as last inspection. 6/23/2014 Same as last inspection.12/17/2013 Same as last inspection.7/22/2013 Same as last inspection.10/30/2012 Slide gate unoperable-blocked by sediment. LS-flap gate missing. 5-inch pipe goes through 24-inch crossing--unable to determine is authorized. This crossing was listed in the USACE Periodic Inspections as ID# USACE_CESPK_MA1C_2010_p_0435 for smaller pipe running inside existing crossing. FIELD_STRUCT_DESC: *ABANDONED* 24-inch corrugated metal drainage pipe through the levee, approximately 10 feet below the crown. Slide gate on both waterside (WS) and landside (LS). Gate missing on the LS. (Automatic Board Order (ABO) issued as Permit No. 9462-1974, Thousand Acre Ranch) [Additional Reference(s): DWR Levee Log, 1992]. FS Date: 5/23/2017 11:50:30 AM

Overview of levee crown looking downstream at crossing.

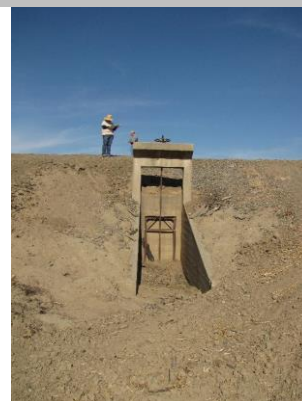
Photo 2 of 3 : UCIP_FA_2018_51903_70351.jpg

WS concrete structure with slide gate. Gate is blocked by sediment.

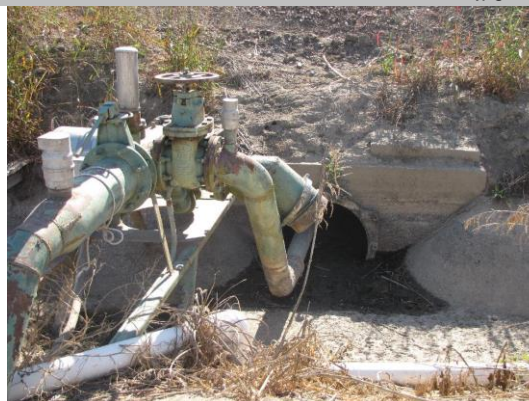
Photo 3 of 3 : UCIP_FA_2018_51903_70350.jpg

6-inch irrigation pipe through crossing at LS. Flap gate missing.

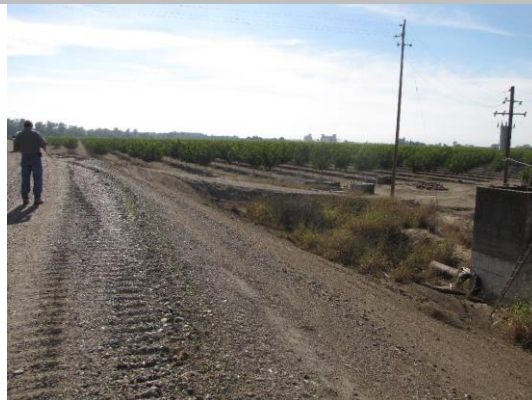
Photo 1 of 3 : UCIP_FA_2018_53058_70377.jpg

FS_ID:53058 DS_ID:16443 EP_NO: 9461 Repair Type: Urgent Crossing Status: Found UCIP Comments: 10/1/2018 Backwash erosion from ditch appears to be growing along LS toe. FSRP evaluation is recommended. (O.Yakimov - DWR)5/3/2017 Water was leaking from the LS distribution box during the Jan/Feb 2017 high water event. If this crossing is abandoned then it needs to be so properly. (DWR Sutter Yard- A Freitag)11/01/2016 Erosion/cavity collapse visible on LS toe. Slide gate inside concrete riser located on the WS is in the open position. Need to contact owner to confirm status of crossing and to determine cause of erosion on LS (pipe or concrete box might be leaking). (O. Magana - DWR UCIP)10/24/2016 Appears abandoned.(DWR Sutter Yard- A Freitag)4/25/2016 Slide gate in WS box visually appears to be closed as its stem is all the way down. Still cannot look into box to confirm 100% though. (A. Freitag - DWR Sutter Yard)4/21/2015 Same as last inspection. (A. Freitag - DWR Sutter Yard)6/23/2014 Same as last inspection. (A. Freitag - DWR Sutter Yard)12/17/2013 Same as last inspection. (A. Freitag - DWR Sutter Yard)7/22/2013 Same as last inspection. (A. Freitag - DWR Sutter Yard)10/30/2012 Unable to close positive closure device due to missing ladder-sluce gate inaccessible. Need to determine the condition of the gate. This crossing was listed in the USACE Periodic Inspections as ID# USACE_CESPK_MA1C_2010_p_0453 for an inaccessible gate box with its ladder broken on the waterward side. (O. Magana - DWR UCIP) FIELD_STRUCT_DESC: 36-inch corrugated metal irrigation pipe through the levee, 21.5 feet below the crown. Slide gate in concrete box on the waterside (WS) end. Pump on the bank. Tall concrete box located on the landside (LS). (Automatic Board Order (ABO) issued as Permit No. 9461, 1974 - Annie D. Propfe) [Additional Reference(s): DWR Levee Log, 1992. USACE Sacramento O&M Manual 137, August 1955, (Station 710+82)]. FS Date: 10/1/2018 4:06:00 PM

View of LS looking downstream at crossing.

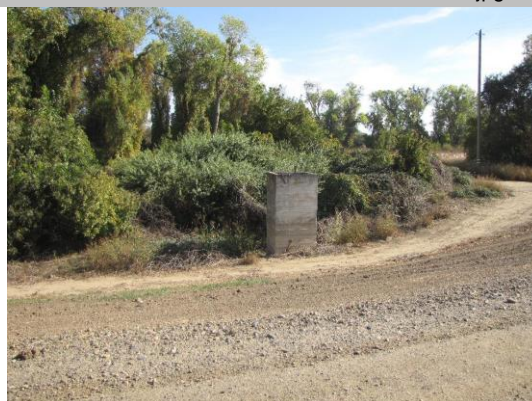
Photo 2 of 3 : UCIP_FA_2018_53058_70376.jpg

UCIP Comments: 10/1/2018 Backwash erosion from ditch appears to be growing along LS toe. FSRP evaluation is recommended. (O.Yakimov - DWR)5/3/2017 Water was leaking from the LS distribution box during the Jan/Feb 2017 high water event. If this crossing is abandoned then it needs to be so properly. (DWR Sutter Yard- A Freitag)11/01/2016 Erosion/cavity collapse visible on LS toe. Slide gate inside concrete riser located on the WS is in the open position. Need to contact owner to confirm status of crossing and to determine cause of erosion on LS (pipe or concrete box might be leaking). (O. Magana - DWR UCIP)10/24/2016 Appears abandoned.(DWR Sutter Yard- A Freitag)4/25/2016 Slide gate in WS box visually appears to be closed as its stem is all the way down. Still cannot look into box to confirm 100% though. (A. Freitag - DWR Sutter Yard)4/21/2015 Same as last inspection. (A. Freitag - DWR Sutter Yard)6/23/2014 Same as last inspection. (A. Freitag - DWR Sutter Yard)12/17/2013 Same as last inspection. (A. Freitag - DWR Sutter Yard)7/22/2013 Same as last inspection. (A. Freitag - DWR Sutter Yard)10/30/2012 Unable to close positive closure device due to missing ladder-sluce gate inaccessible. Need to determine the condition of the gate. This crossing was listed in the USACE Periodic Inspections as ID# USACE_CESPK_MA1C_2010_p_0453 for an inaccessible gate box with its ladder broken on the waterward side. (O. Magana - DWR UCIP)

View of WS at crossing.

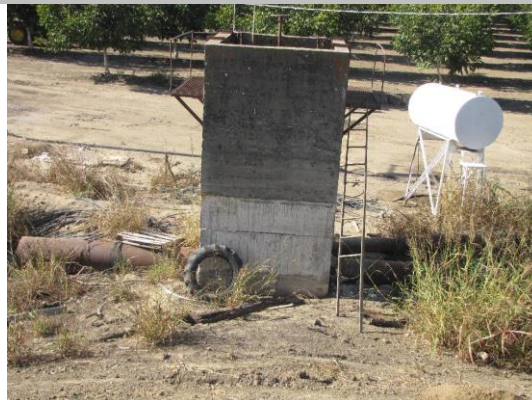
Photo 3 of 3 : UCIP_FA_2018_53058_70375.jpg

FS_ID:53058
DS_ID:16443
EP_NO: 9461
Repair Type: Urgent
Crossing Status: Found
UCIP Comments: 10/1/2018 Backwash erosion from ditch appears to be growing along LS toe. FSRP evaluation is recommended. (O.Yakimov - DWR)5/3/2017 Water was leaking from the LS distribution box during the Jan/Feb 2017 high water event. If this crossing is abandoned then it needs to be so properly. (DWR Sutter Yard- A Freitag)11/01/2016 Erosion/cavity collapse visible on LS toe. Slide gate inside concrete riser located on the WS is in the open position. Need to contact owner to confirm status of crossing and to determine cause of erosion on LS (pipe or concrete box might be leaking). (O. Magana - DWR UCIP)10/24/2016 Appears abandoned.(DWR Sutter Yard- A Freitag)4/25/2016 Slide gate in WS box visually appears to be closed as its stem is all the way down. Still cannot look into box to confirm 100% though. (A. Freitag - DWR Sutter Yard)4/21/2015 Same as last inspection. (A. Freitag - DWR Sutter Yard)6/23/2014 Same as last inspection. (A. Freitag - DWR Sutter Yard)12/17/2013 Same as last inspection. (A. Freitag - DWR Sutter Yard)7/22/2013 Same as last inspection. (A. Freitag - DWR Sutter Yard)10/30/2012 Unable to close positive closure device due to missing ladder-sluce gate inaccessible. Need to determine the condition of the gate. This crossing was listed in the USACE Periodic Inspections as ID# USACE_CESPK_MA1C_2010_p_0453 for an inaccessible gate box with its ladder broken on the waterward side. (O. Magana - DWR UCIP)

Concrete distribution box located on LS toe.

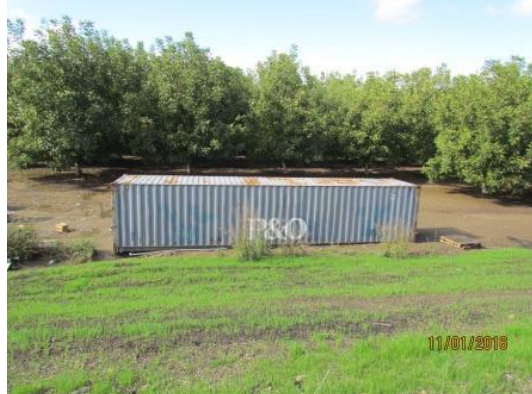
Photo 1 of 1 : FA_2018_MA0001_297_126_20180905_00036.jpg

LM Start	13.48	Rating **	M	Issue No.	126
LM End	13.48	Issue Type +	En	Location *	LS
Category	Earthen Levee			GPS Latitude/Longitude	
				Start	End
Item	Encroachments			39.367832 °	39.367832 °
				-122.015130 °	-122.015130 °
DWR ID	DWR_MA0001_01_f_2016_126				
Comment Code					
EQ : Equipment					
Inspector Comment					
Shipping container stored on landside toe.

View of a shipping container along the landside toe.

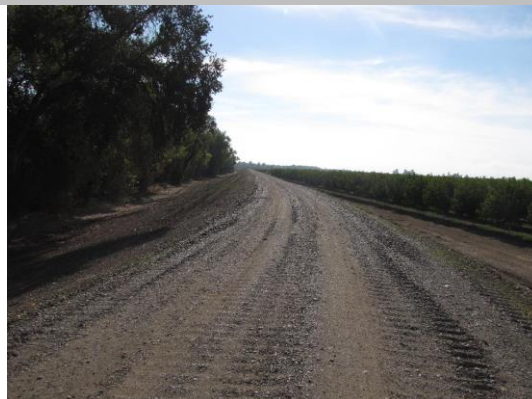
Photo 1 of 2 : UCIP_FA_2018_51910_70379.jpg

Comment Code						
Inspector Comment						
FS_ID:51910 DS_ID:16442 EP_NO: N/A Repair Type: Non-Urgent Crossing Status: Found UCIP Comments: 5/3/2017 Abandoned- needs to be done so properly. (DWR Sutter Yard- A Freitag)10/24/2016 Abandoned.(DWR Sutter Yard- A Freitag)4/25/2016 Abandoned crossing4/21/2015 Slide gate is still buried.6/23/2014 Same as last inspection.12/17/2013 Same as last inspection.7/22/2013 Same as last inspection.10/30/2012 Slide gate is buried-non-fuctional. This crossing was listed in the USACE Periodic Inspections as ID# USACE_CESPK_MA1C_2010_p_0457 for buried slide gate. FIELD_STRUCT_DESC: *ABANDONED* 36-inch corrugated metal drainage pipe through the levee at approximately 15-18 feet below the crown. Slide gate on the waterside (WS) end. (Davis Ranches) [Additional Reference(s): DWR Levee Log, 1992]. FS Date: 5/23/2017 12:02:52 PM

Overview of levee crown looking downstream at crossing.

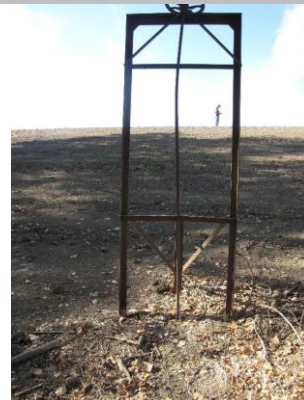
Photo 2 of 2 : UCIP_FA_2018_51910_70380.jpg

Item	DWR UCIP Field Study			39.371934 °	39.371934 °	
				-122.012945 °	-122.012945 °	
DWR ID	16442					
Comment Code						
Inspector Comment						
FS_ID:51910 DS_ID:16442 EP_NO: N/A Repair Type: Non-Urgent Crossing Status: Found UCIP Comments: 5/3/2017 Abandoned- needs to be done so properly. (DWR Sutter Yard- A Freitag)10/24/2016 Abandoned.(DWR Sutter Yard- A Freitag)4/25/2016 Abandoned crossing4/21/2015 Slide gate is still buried.6/23/2014 Same as last inspection.12/17/2013 Same as last inspection.7/22/2013 Same as last inspection.10/30/2012 Slide gate is buried-non-fuctional. This crossing was listed in the USACE Periodic Inspections as ID# USACE_CESPK_MA1C_2010_p_0457 for buried slide gate. FIELD_STRUCT_DESC: *ABANDONED* 36-inch corrugated metal drainage pipe through the levee at approximately 15-18 feet below the crown. Slide gate on the waterside (WS) end. (Davis Ranches) [Additional Reference(s): DWR Levee Log, 1992]. FS Date: 5/23/2017 12:02:52 PM

WS-Slide gate buried-non-functional.

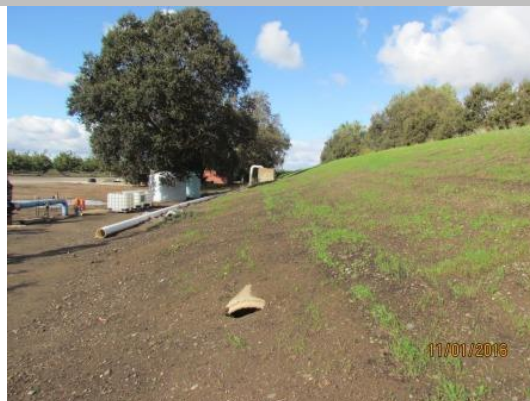
Photo 1 of 1 : FA_2018_MA0001_297_128_20180905_00037.jpg

LM Start	14.25	Rating **	U	Issue No.	128
LM End	14.30	Issue Type +	En	Location *	LS
Category	Earthen Levee			GPS Latitude/Longitude	
				Start	End
Item	Encroachments			39.378129 °	39.378800 °
				-122.013040 °	-122.013360 °
DWR ID	DWR_MA0001_01_f_2016_128				
Comment Code					
PI : Pipe					
Inspector Comment					
Concrete pipe runs along the landside toe and concrete box at the end.

View of a concrete pipe that runs along the levee toe.
